COMPARITIVE SCALED MMLS3 TESTS VS. FULL-SCALE MLS10 TESTS IN MOZAMBIQUE

AUGUST 2006

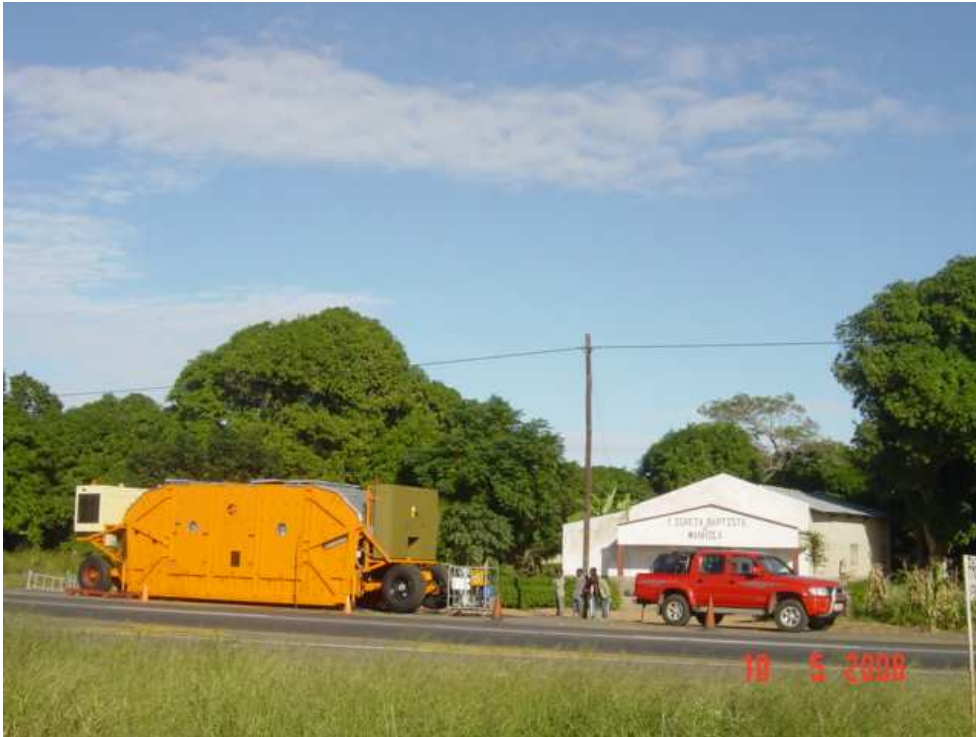
FIGURE 1 View of the MLS10 on the test site at Manhiça in Mozambique during trafficking

MLS10 is operational since April 2006. Four sets of dual wheels each loaded to 60kN run in a closed loop with a maximum speed of up to 26kph. Operation is similar to the MMLS3. The latter was has four single tyres each carrying 2.7 kN. Ten MMLS3 tests including two field tests have been completed as well as three MLS10 tests.

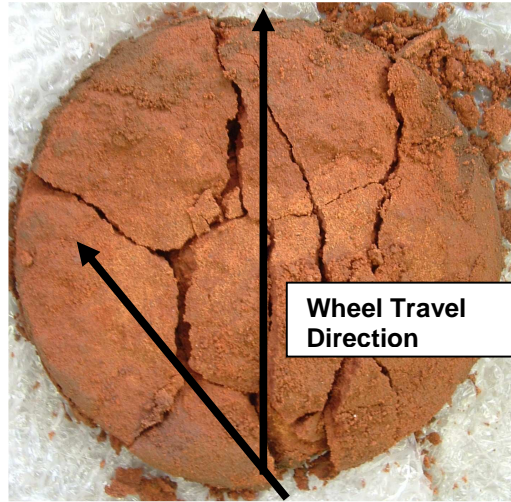
19 **FIGURE 2** Top view of lower half of red sand 3 % CTB layer exhibiting shear failure, failure planes
20 parallel to direction of travel on edges of wheel track.

1
2
3 Figures 2 and 3 depict images taken after the diagnostic analyses of the test pavements. Such
4 diagnostic views are of great help in determining the nature of the distress in a pavement system. Details
5 pertaining to the respective tests can be found in Table 3.

17 The order and direction of development was dependent on structural composition, material
18 properties and construction history. Some typical failure mechanisms are depicted in the photos in Figures 2 and
19 3.

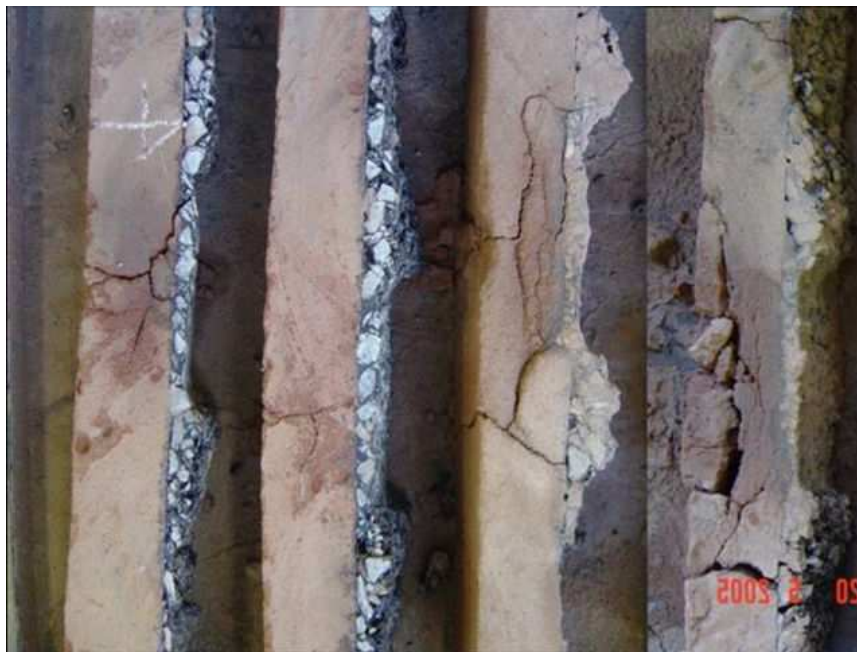
40 **FIGURE 3a** Side view of beams taken from 3 percent cement section. Note different phases of failure.

A trench was excavated across the wheel path of section 4 to explore the nature of distress. Figure 10a and 10b show the extracted block structure reconstituted to reflect the geomorphology. The underside of the asphalt surfacing with marked cracks is shown in Figure 10c. The similarity of the distress between the full-scale and the laboratory scaled pavements is apparent from the MMLS3 diagnostic specimens shown in Figures 3a and 3b.

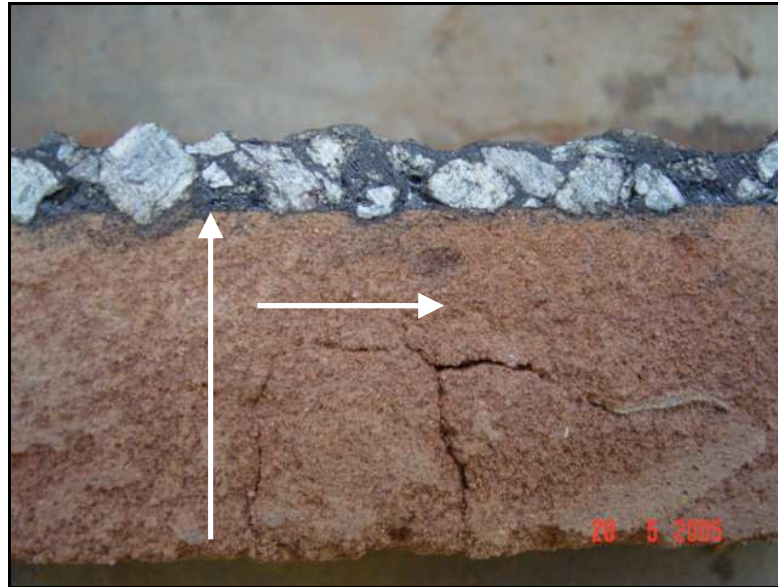
FIGURE 3b Close up of 3 percent cement beam with seal, extracted from the scaled laboratory pavement, shear plane on neutral axis clearly visible (50 mm high, length of shear plane 20 mm)

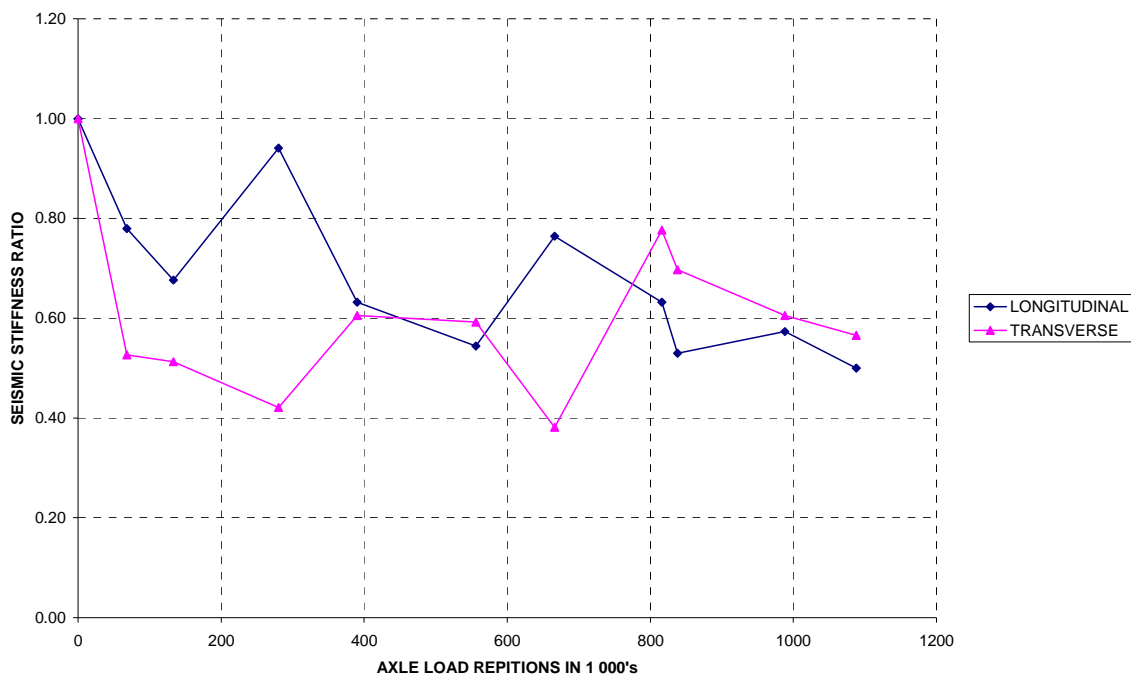
FIGURE 4 Stiffness ratios vs. MMLS3 load applications for 5% cement stabilized red sand base with asphalt surfacing – measured at a point 300 mm from the start of the test section, in longitudinal and transverse relative to traffick direction

A steeper gradient of stiffness loss is indicative of a more rapid rate of deterioration of the composite pavement. On the other hand a positive increase in the gradient is indicative of a gain in strength. During initial trafficking the 7 percent cement and lime mix exhibited this characteristic. Once it had reached a peak value the loss in stiffness of the 7 percent cement and lime mix was more rapid than the 7 percent cement mix.

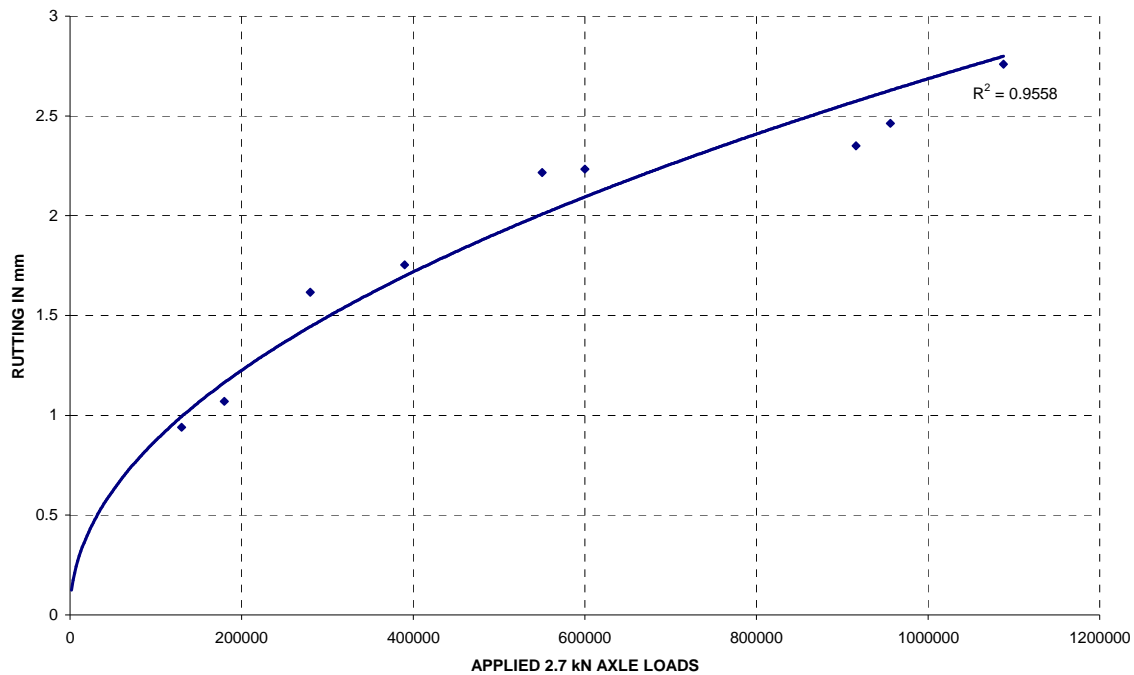
FIGURE 5 Cumulative rut depth with load application for 5 % cement stabilized red sand base with 20 mm asphalt surfacing.

pavements, the initial increase in rutting of the composite CTB HMA pavement was more gradual. From a comparison of Figure 5 and 9b it is apparent that the rutting performance of the scaled and full-scale pavements was similar.

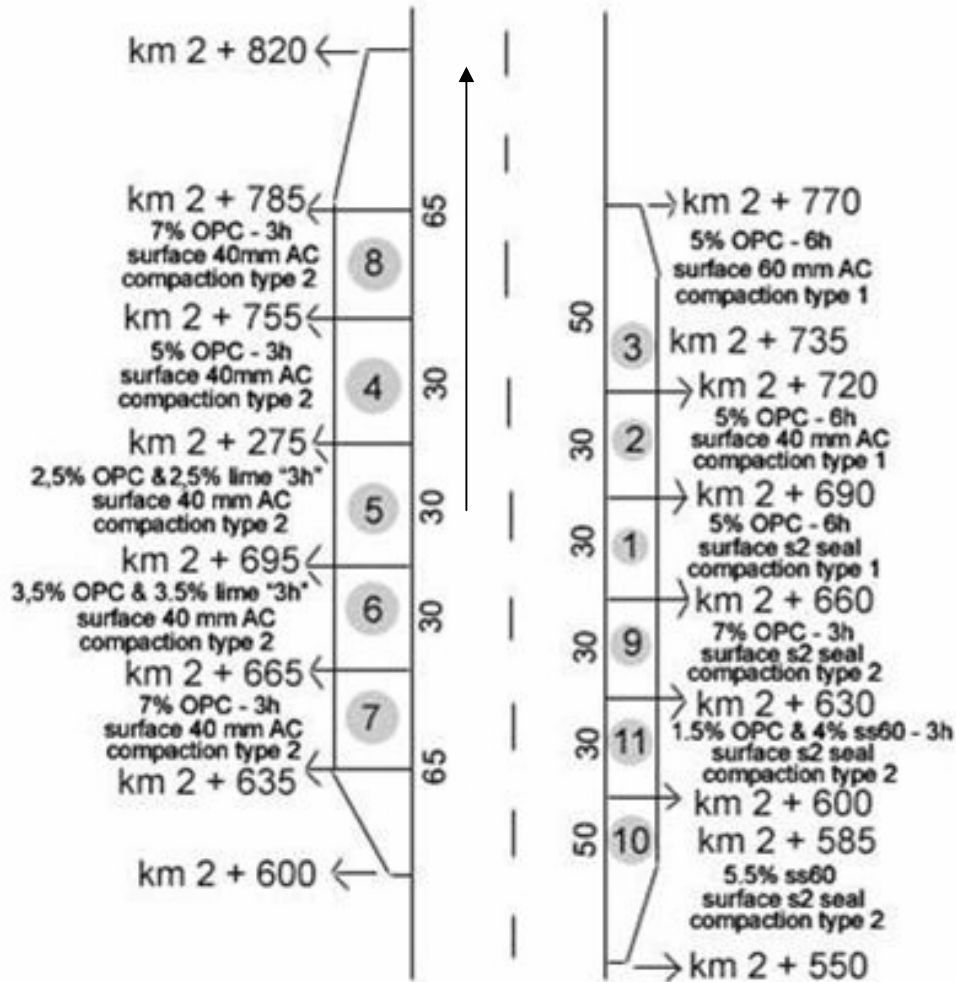
FIGURE 6 Plan view of Test Sections constructed in June 2005

21 The specifications for the test sections that were to be built for APT testing were
22 established from the results of the scaled laboratory MML3 performance and issued for construction. Related
23 sampling and testing requirements were also proposed. The construction of test sections was executed according
24 to prescribed guidelines. This was to follow current construction methodology and varying compaction of the
25 cement treated base material with respect to roller type and number of passes. Figure 6 depicts the location of
26 the respective test sections in the test arena. This newly constructed sections are adjacent to the existing
27 rehabilitated road, highway EN1, and are to be utilized as bus stops after testing is complete. Base thickness of
28 all test sections are 150 mm and were constructed on the same subgrade material. Surface type and thickness
29 vary and details are set out in Table 4 and indicated in Figure 6.

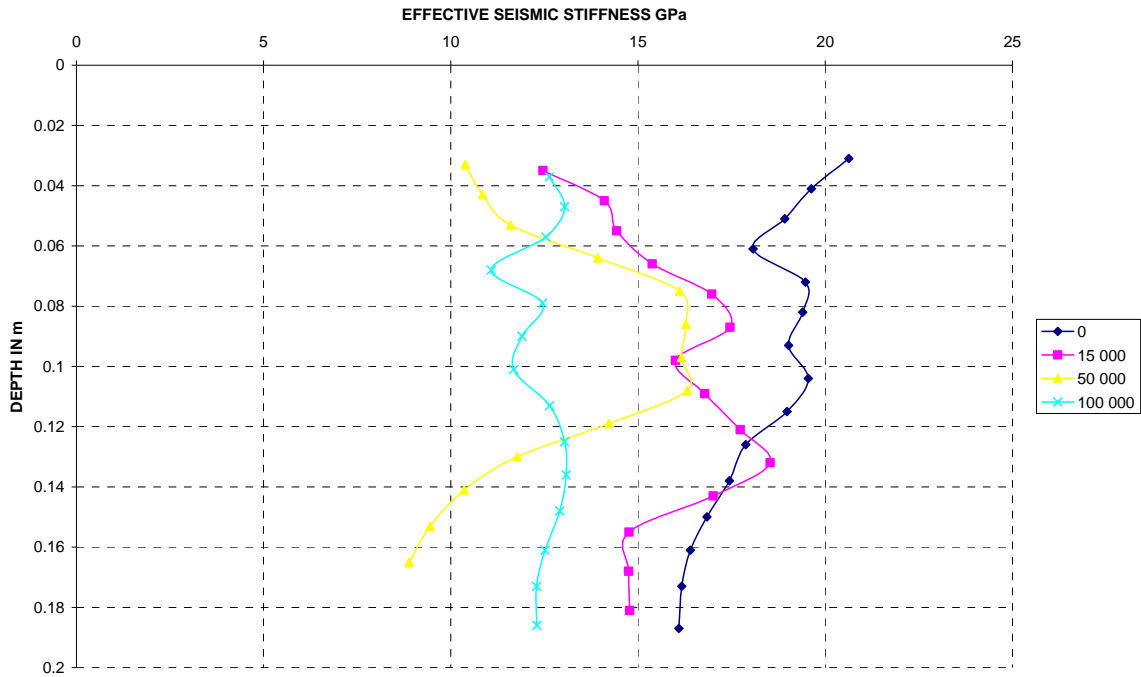
FIGURE 7a Typical Seismic Stiffness Profiles with Axle Load Application at a specific point relative to the wheel track

The stiffness of upper 200 mm of the pavement structure was measured at regular intervals during trafficking by means of the PSPA. Typical seismic modulus plots for a specific position in the test section relative to the wheel path are shown in Figure 7a. The change in stiffness is clearly evident as the trafficking increased. PSPA measurements were taken at five locations relative to the wheel configuration, at three different points along the test section.

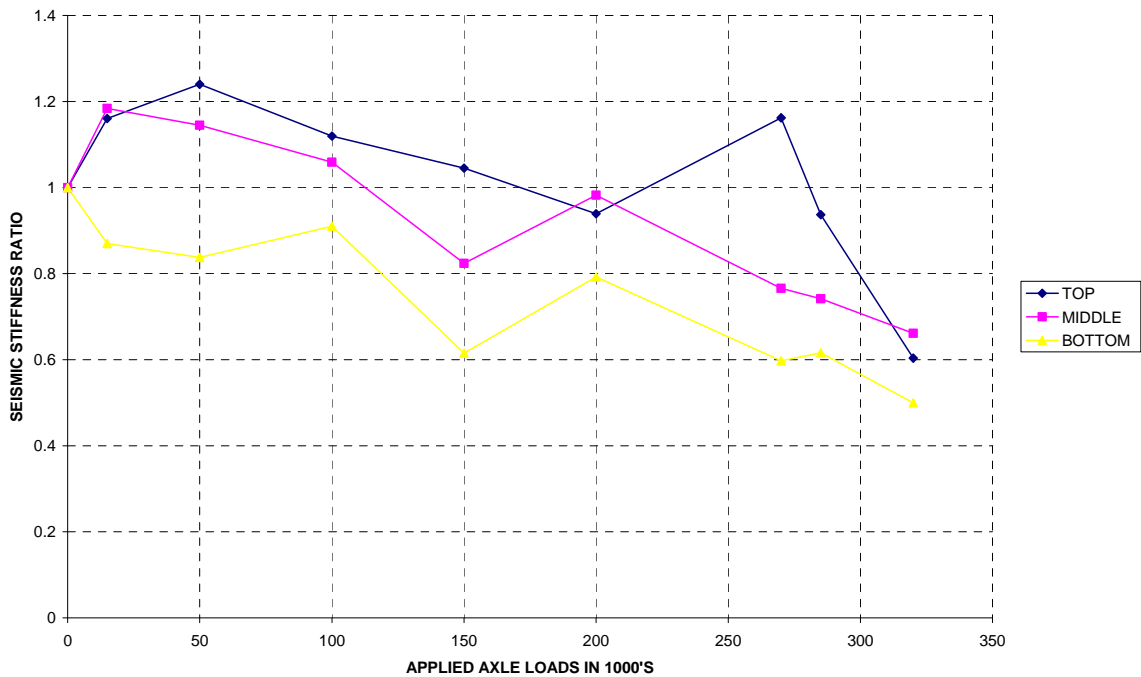
FIGURE 7b Seismic Stiffness Ratios vs. Load Application for Section 4, Position 2 in the Left Wheel track, Longitudinal Direction

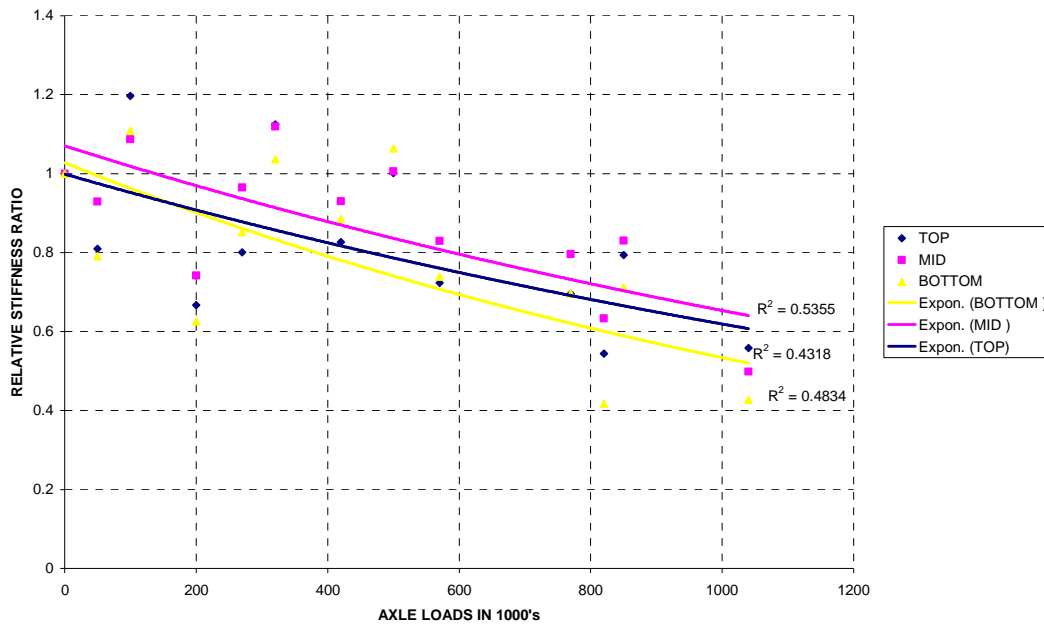
FIGURE 7c Trends in stiffness reduction for Section 5b Position 2 in the Left Wheel track, Longitudinal to the direction of traffic

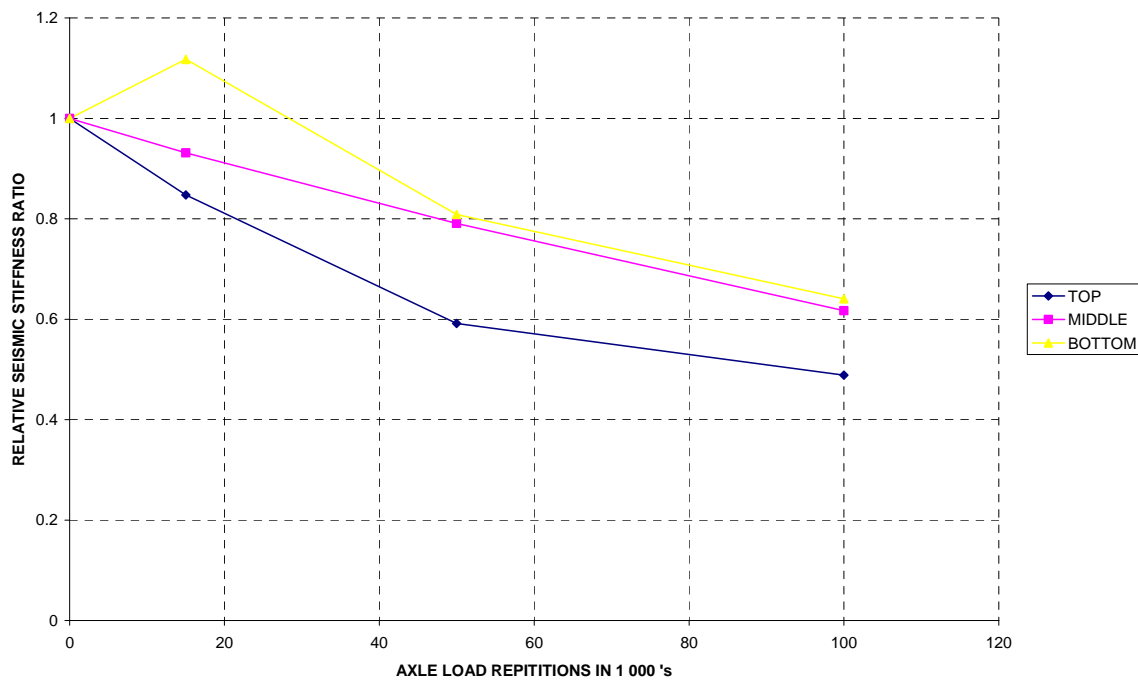
FIGURE 7d Relative Seismic Stiffness Ratio vs. Axle Load Repetitions for Section 5A Left Wheel Track Measured in Transverse Direction

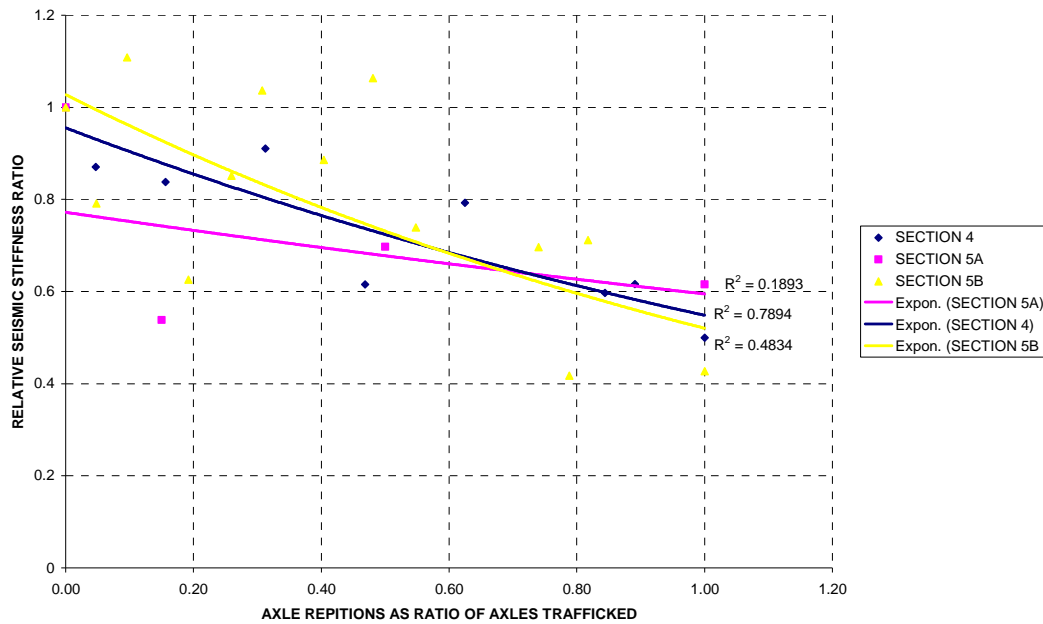
FIGURE 7e Relative Seismic Stiffness Ratio vs. Trafficked Axle Ratio for Test Sections 4, 5A and 5B, depicting relative trends in performance.

The findings were as expected namely a reduction due to the distress under the trafficking. More important was the nature of the change in the stiffness. In general the change in longitudinal stiffness was more than that in the transverse direction. This was probably to a large extent due to the faster growth in the cracks in the transverse direction than the cracks in the longitudinal direction. Figure 7 b, d illustrate the relative decrease in stiffness for specific points under the loading wheel, where Figure 7c illustrates the trends in stiffness performance with load application.

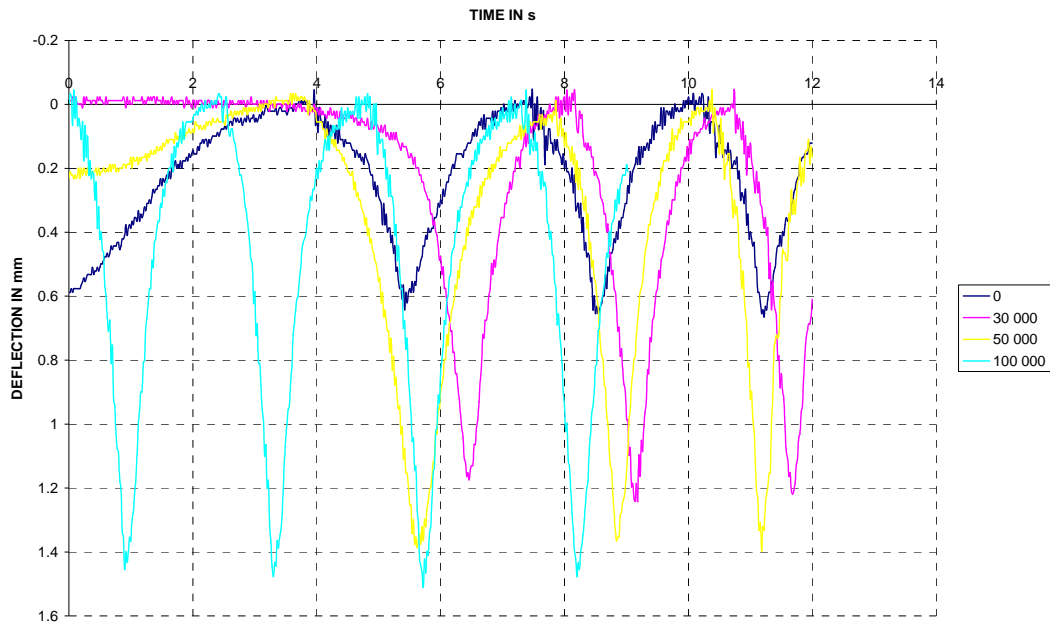
FIGURE 8a Deflection profiles for section 5a monitored at intervals during axle load trafficking

As the pavement suffered distress the deflections progressively increased. See Figure 8a. When the trafficking was terminated the deflections had in general doubled relative to the initial deflections. This response was just the opposite of the stiffness ratios that were discussed earlier. The two parameters were inversely proportionate to each other.

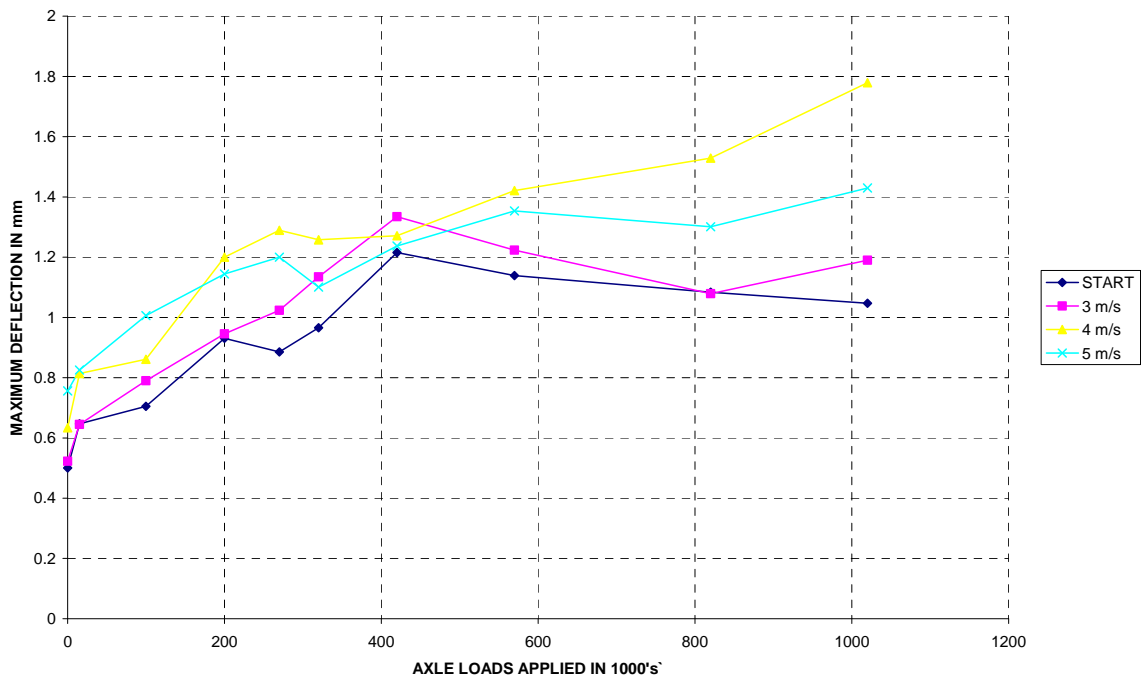
FIGURE 8b Maximum Deflection at Slow Speed for Section 5B vs. Axle Load Application

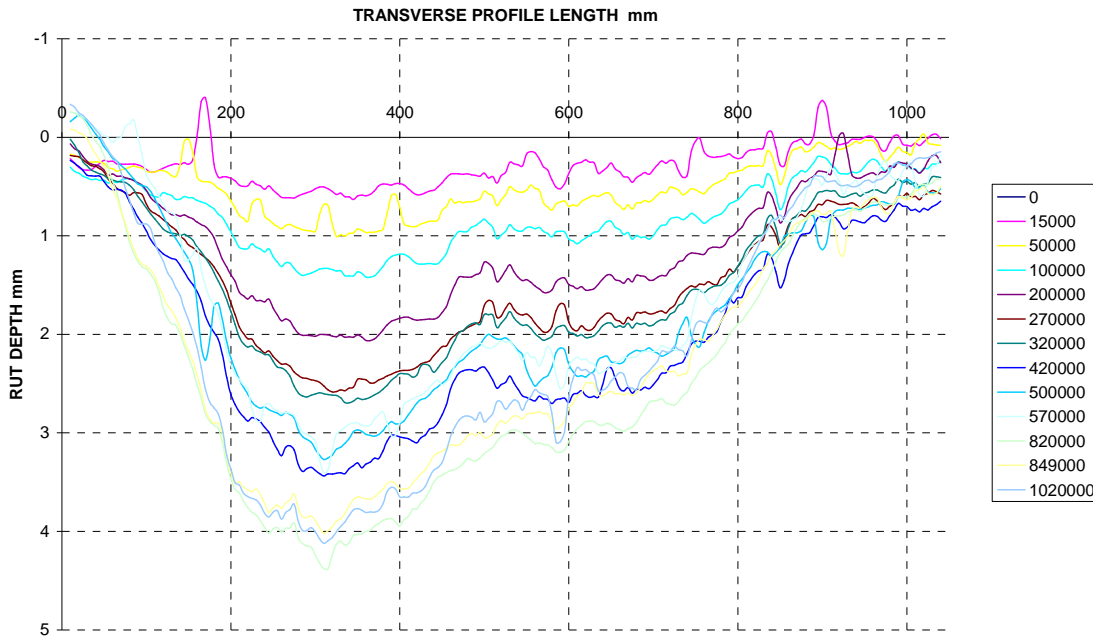
FIGURE 9a Transverse rutting profiles with load applications for the center of MLS10 Test section 5

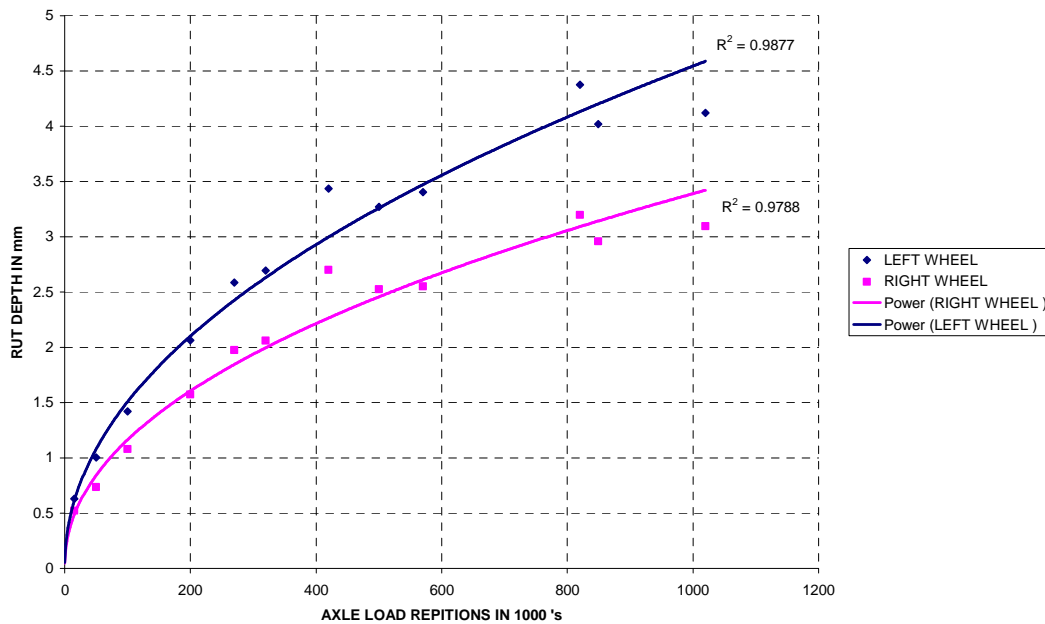
FIGURE 9b Cumulative maximum rut depth at the middle of MLS10 test section 5 - left and right wheel path

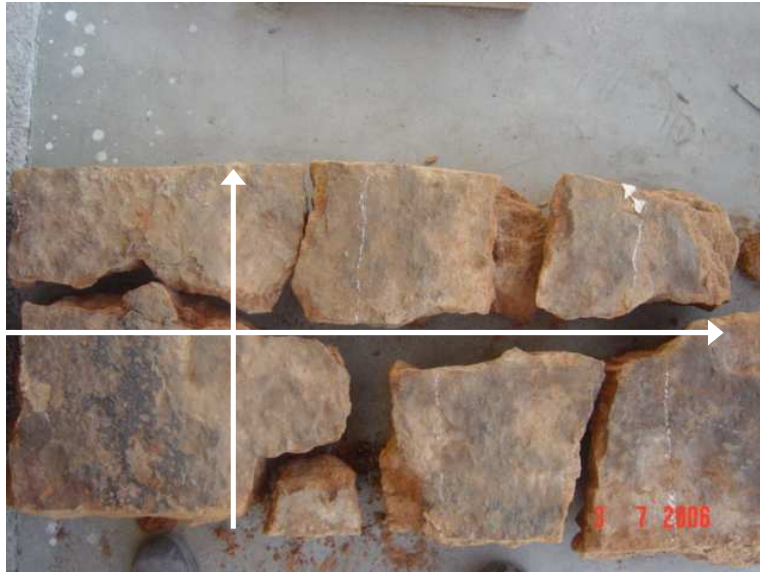
FIGURE 10a Plan View of the CTB slab extracted from full scale test section 4 for diagnostic investigation (550x1200)

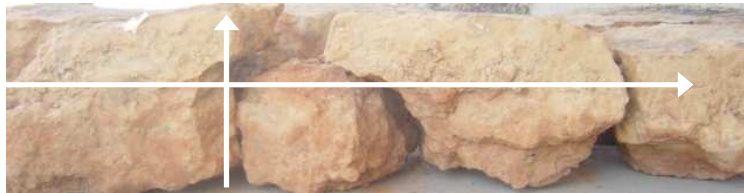
FIGURE 10b Elevation View of the CTB slab extracted from full-scale test section 4 for diagnostic investigation (160x1200)

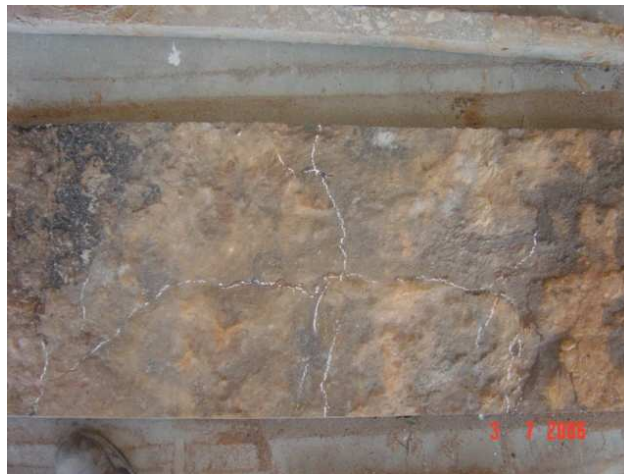
FIGURE 10c View of underside of HMA extracted from full scale test section 4 for diagnostic investigation showing marked positions of cracks.
